**Flood Control Project Maintenance
Levee Inspections**

Maintenance Issue Types Only, Levee Inspection Report By Mile - Spring 2015

Reclamation District No. 0765 Glide

Waterway	Bank	Unit Miles	Inspection Start/End	Inspector
Unit No. 01 Sacramento River	Right	1.72	04/23/2015 04/23/2015	Richard Willoughby

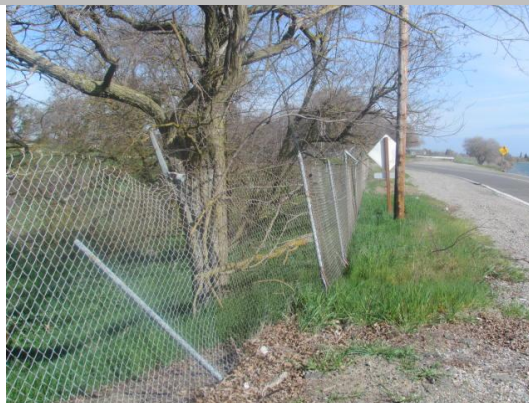
Photo 1 of 1 : SP_2015_RD0765_211_3_20150309_00003.jpg

LM Start	0.05	Rating **	M	Issue No.	3
LM End	0.05	Issue Type +	Ma	Location *	LS
Category	Earthen Levee			GPS Latitude/Longitude	
				Start	End
Item	Trim / Thin Trees			38.502253 °	38.502253 °
				-121.560192 °	-121.560192 °
DWR ID	DWR_RD0765_01_s _ 2012_3				
Action/Comments					
Trim trees to at least five feet above ground level.

Looking north (upstream) at trees on landside slope.

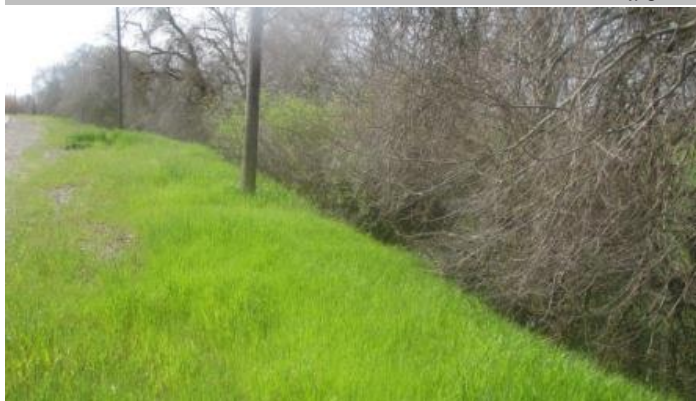
Photo 1 of 2 : SP_2015_RD0765_211_28_20150309_00028.jpg

LM Start	0.12	Rating **	M	Issue No.	28
LM End	0.19	Issue Type +	Ma	Location *	LS
Category	Earthen Levee			GPS Latitude/Longitude	
				Start	End
Item	Trim / Thin Trees			38.501215 °	38.500271 °
				-121.560432 °	-121.560434 °
DWR ID	DWR_RD0765_01_s_2012_28				
Action/Comments					
Trim and thin trees to allow visibility of the ground and room to flood fight.

Looking downstream (south) at trees on landside slope & toe.

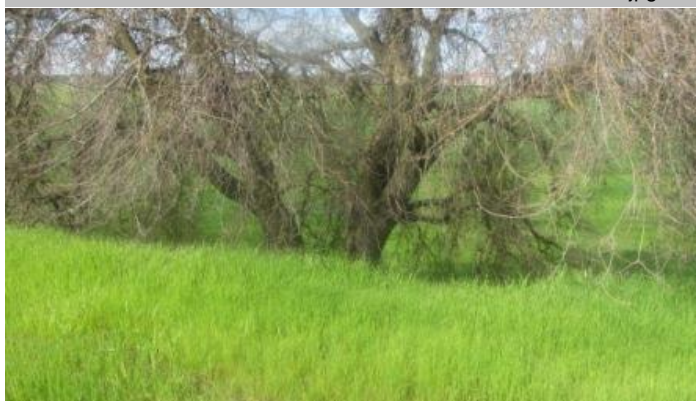
Photo 2 of 2 : SP_2015_RD0765_211_28_20150309_00029.jpg

Looking west at trees on landside toe.

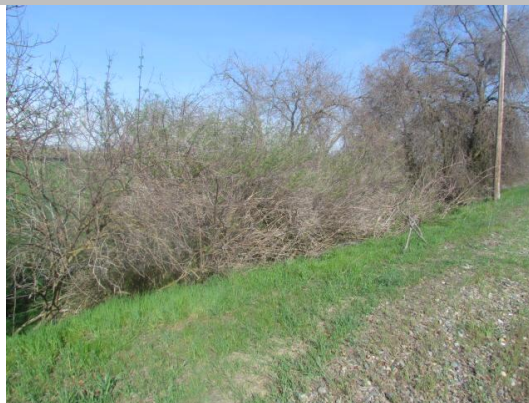
Photo 1 of 1 : SP_2015_RD0765_211_22_20150309_00025.jpg

LM Start	0.14	Rating **	M	Issue No.	22
LM End	0.14	Issue Type +	Ma	Location *	LS
Category	Earthen Levee			GPS Latitude/Longitude	
				Start	End
Item	Vegetation			38.500928 °	38.500928 °
				-121.560431 °	-121.560431 °
DWR ID	DWR_RD0765_01_s _ 2012_22				
Action/Comments					
Elderberries are blocking visibility and flood fight capability.

Looking northwest at dense vegetation on landside slope.

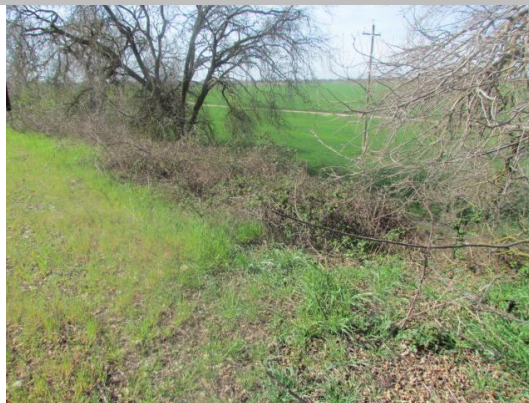
Photo 1 of 1 : SP_2015_RD0765_211_49_20150309_00050.jpg

Looking at wild berryvines or wild roses on landside slope and toe.

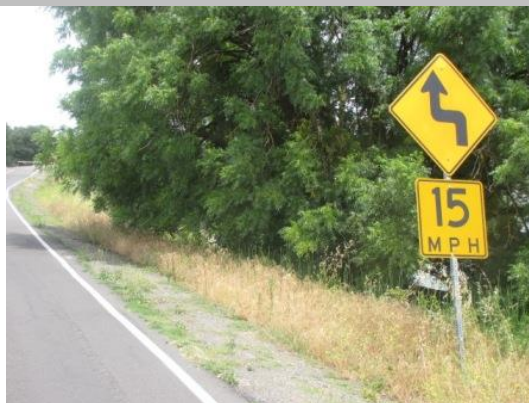
Photo 1 of 5 : SP_2015_RD0765_211_11_20150309_00011.jpg

LM Start	0.25	Rating **	A/W	Issue No.	11
LM End	0.27	Issue Type +	Ma	Location *	WS
Category	Earthen Levee			GPS Latitude/Longitude	
				Start	End
Item	Trim / Thin Trees			38.499405 °	38.499042 °
				-121.560445 °	-121.560430 °
DWR ID	DWR_RD0765_01_s _ 2012_11				
Action/Comments					
Thin trees to allow visibility of the ground and room to flood fight.

Looking northeast at overgrown trees on waterside slope.

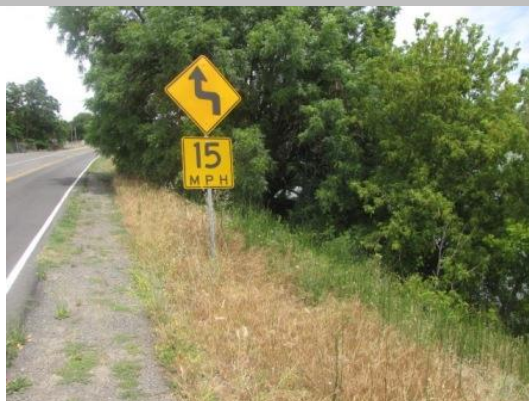
Photo 2 of 5 : SP_2015_RD0765_211_11_20150309_00012.jpg

Looking north at dense trees on waterside slope from fall 2010 inspection.

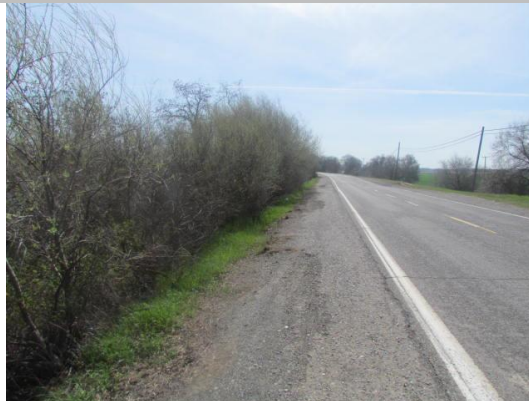
Photo 3 of 5 : SP_2015_RD0765_211_11_20150309_00013.jpg

Looking south (downstream) at dense trees on landside slope and shoulder. (Spring 2013)

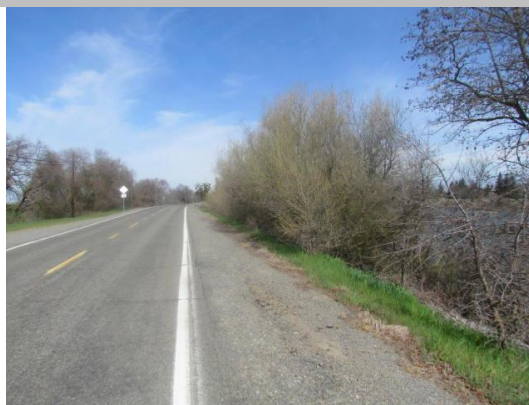
Photo 4 of 5 : SP_2015_RD0765_211_11_20150309_00014.jpg

Looking north (upstream) at dense trees on landside slope and shoulder. (Spring 2013)

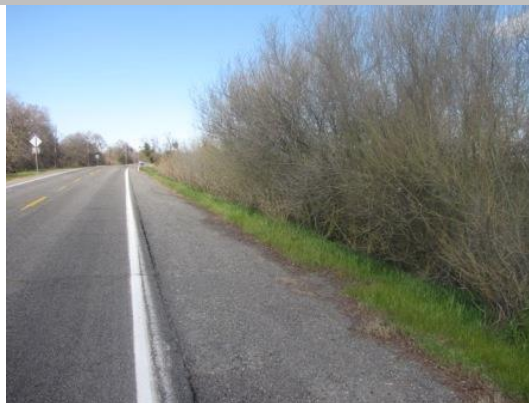
Photo 5 of 5 : SP_2015_RD0765_211_11_20150309_00015.jpg

Looking upstream (north) at dense vegetation and trees from 2011 spring inspection.

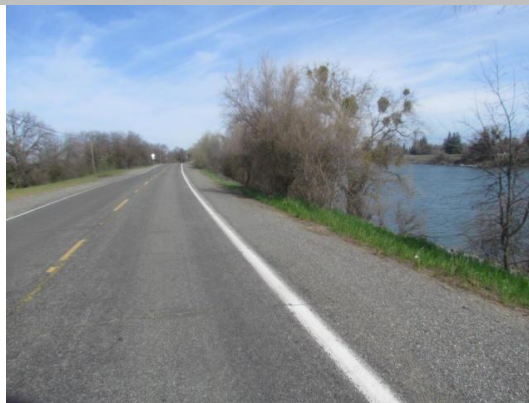
Photo 1 of 1 : SP_2015_RD0765_211_23_20150309_00026.jpg

Looking north (upstream) at untrimmed trees on waterside shoulder and slope.

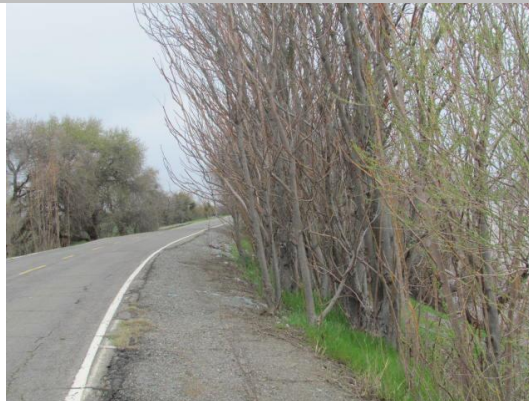
Photo 1 of 1 : SP_2015_RD0765_211_24_20150309_00027.jpg

Looking north (upstream) at untrimmed trees on waterward slope.

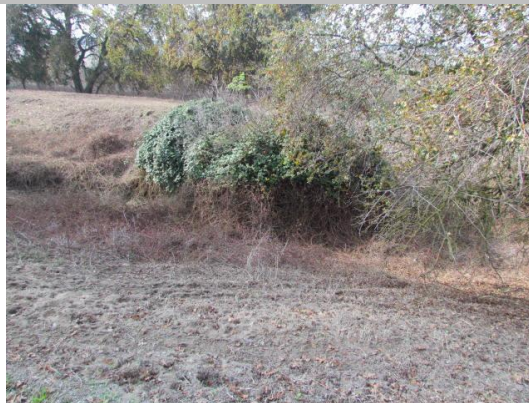
Photo 1 of 1 : SP_2015_RD0765_211_47_20150309_00048.jpg

LM Start	0.41	Rating **	U	Issue No.	47
LM End	0.41	Issue Type +	Ma	Location *	LS
Category	Earthen Levee			GPS Latitude/Longitude	
				Start	End
Item	Vegetation			38.497069 °	38.497069 °
				-121.560106 °	-121.560106 °
DWR ID	DWR_RD0765_01_f_2012_47				
Action/Comments					
Remove the wild growth other than native grasses from the levee slopes.					
Inspector Comments: Wild berryvines on landside toe.

Looking west at dense berryvines on landside toe.

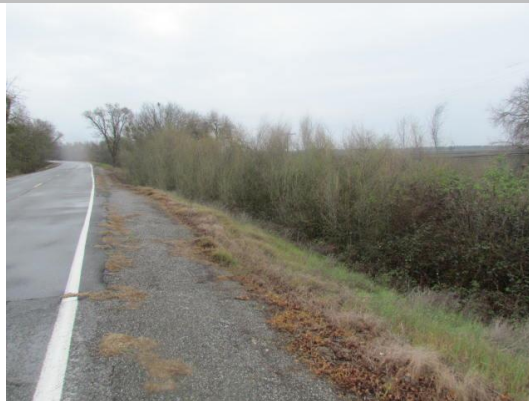
Photo 1 of 1 : SP_2015_RD0765_211_32_20150309_00036.jpg

LM Start	0.43	Rating **	M	Issue No.	32
LM End	0.46	Issue Type +	Ma	Location *	LS
Category	Earthen Levee			GPS Latitude/Longitude	
				Start	End
Item	Trim / Thin Trees			38.496792 °	38.496321 °
				-121.560026 °	-121.559842 °
DWR ID	DWR_RD0765_01_s_2012_32				
Action/Comments					
Trim and thin trees to allow visibility of the ground and room to flood fight.

Looking southwest at dense vegetation on landside slope and toe.

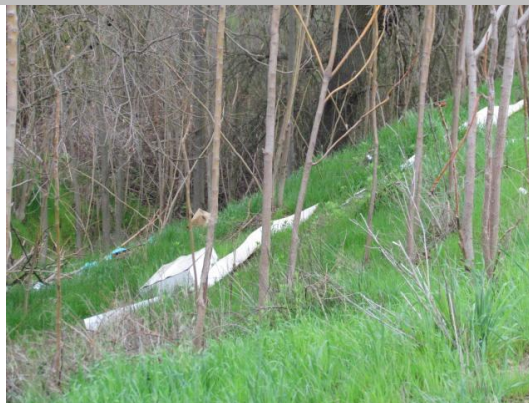
Photo 1 of 2 : SP_2015_RD0765_211_55_20150309_00057.jpg

Looking northwest at garbage on landside slope.

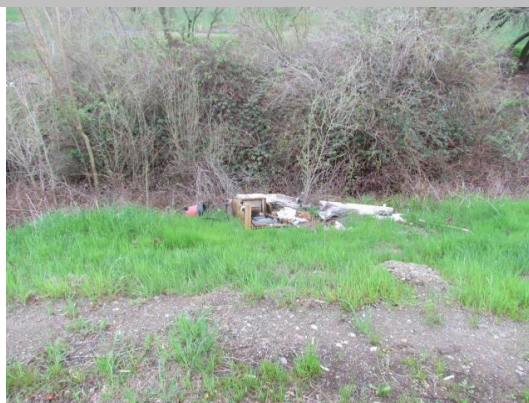
Photo 2 of 2 : SP_2015_RD0765_211_55_20150309_00058.jpg

Looking west at garbage on landside slope.

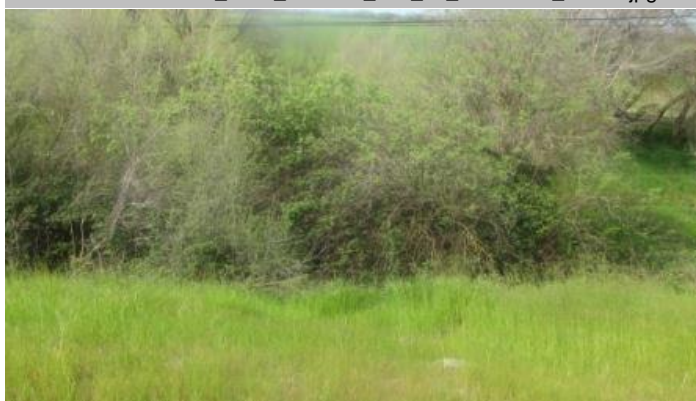
Photo 1 of 5 : SP_2015_RD0765_211_33_20150309_00037.jpg

LM Start	0.47	Rating **	M	Issue No.	33
LM End	0.50	Issue Type +	Ma	Location *	LS
Category	Earthen Levee			GPS Latitude/Longitude	
				Start	End
Item	Vegetation			38.496217 °	38.495855 °
				-121.559788 °	-121.559586 °
DWR ID	DWR_RD0765_01_s_2012_33				
Action/Comments					
Remove the wild growth other than native grasses from the levee slopes.					
Inspector Comments: District removed some of the wild growth on landside slope and toe.

Looking northwest at trees on landside toe from 2010 fall inspection.

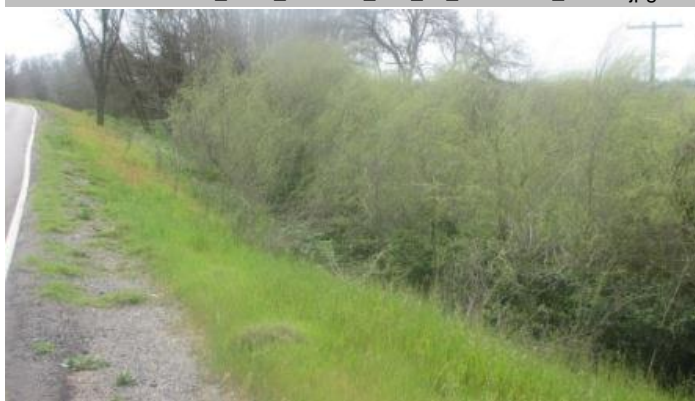
Photo 2 of 5 : SP_2015_RD0765_211_33_20150309_00038.jpg

Looking downstream (south) at trees on landside slope & toe.

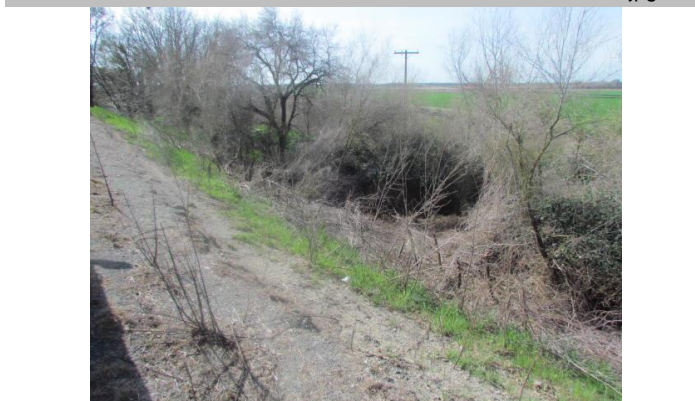
Photo 3 of 5 : SP_2015_RD0765_211_33_20150309_00039.jpg

Looking southwest at dense vegetation on landside slope and toe.

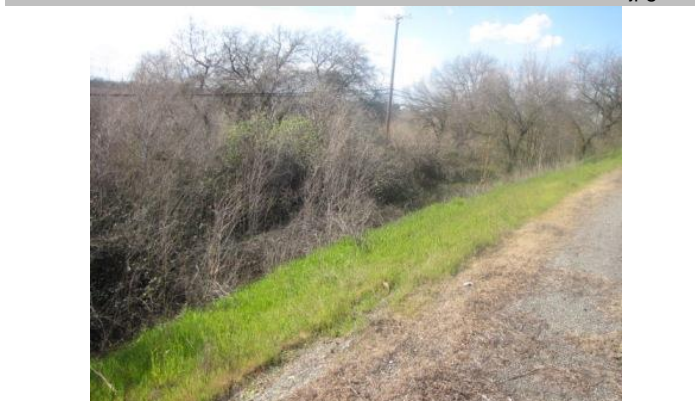
Photo 4 of 5 : SP_2015_RD0765_211_33_20150309_00040.jpg

Looking upstream (northwest) at dense vegetation on landside slope.

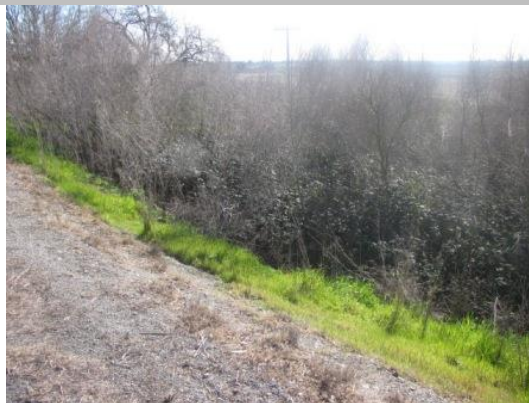
Photo 5 of 5 : SP_2015_RD0765_211_33_20150309_00041.jpg

Looking downstream (southwest) at dense vegetation on landside slope.

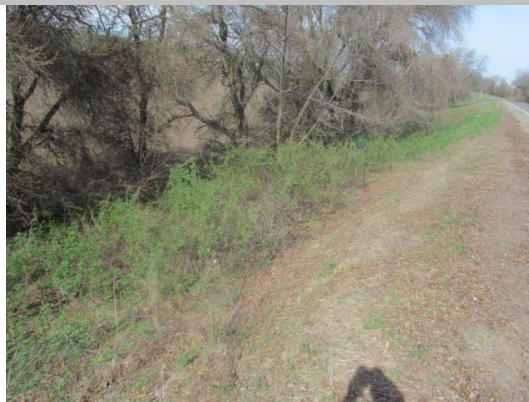
Photo 1 of 1 : SP_2015_RD0765_211_50_20150309_00051.jpg

Looking northwest at vegetation on landside slope.

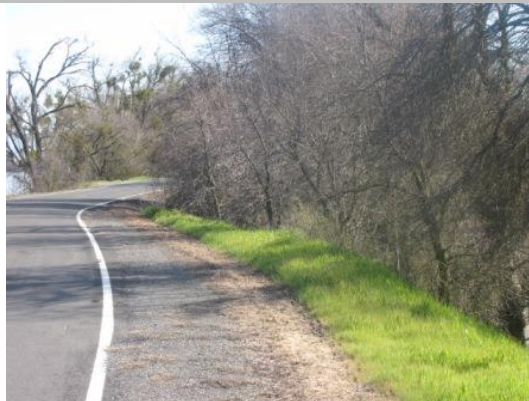
Photo 1 of 6 : SP_2015_RD0765_211_17_20150309_00019.jpg

Looking downstream (south) at dense trees on landside slope and toe.

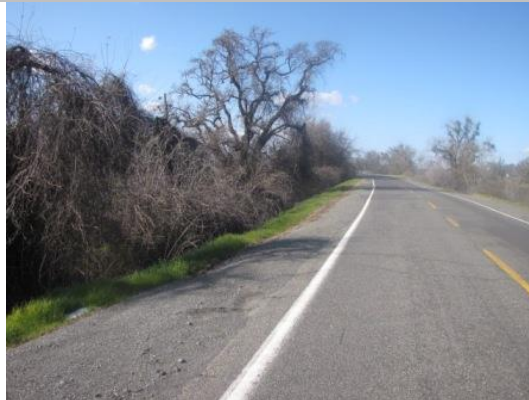
Photo 2 of 6 : SP_2015_RD0765_211_17_20150309_00020.jpg

Looking upstream (north) at dense trees on landside slope and toe.

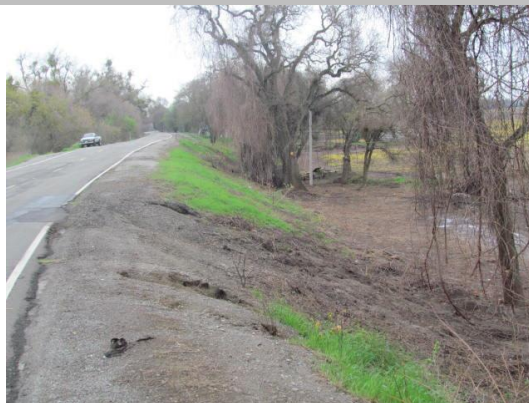
Photo 3 of 6 : SP_2015_RD0765_211_17_20150309_00021.jpg

Looking south at trimmed trees and vegetation on landside slope and toe.

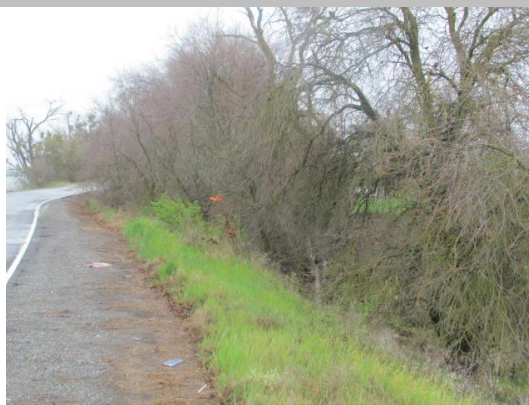
Photo 4 of 6 : SP_2015_RD0765_211_17_20150309_00022.jpg

Looking southwest at dense trees on landside slope and toe spring 2012.

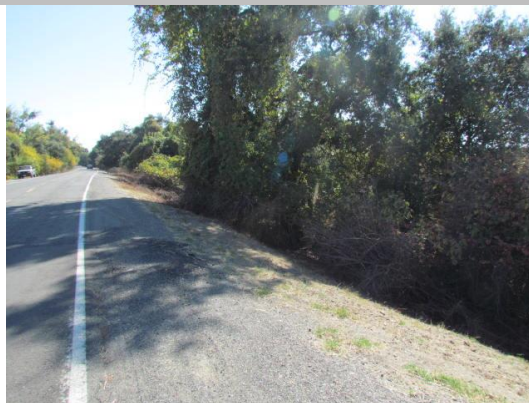
Photo 5 of 6 : SP_2015_RD0765_211_17_20150309_00023.jpg

Looking southwest at dense vegetation on landward slope.

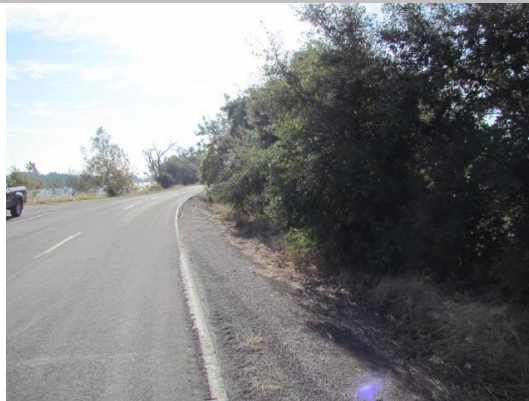
Photo 6 of 6 : SP_2015_RD0765_211_17_20150309_00024.jpg

Looking south at dense trees on landside shoulder and slope.
(November 2011)

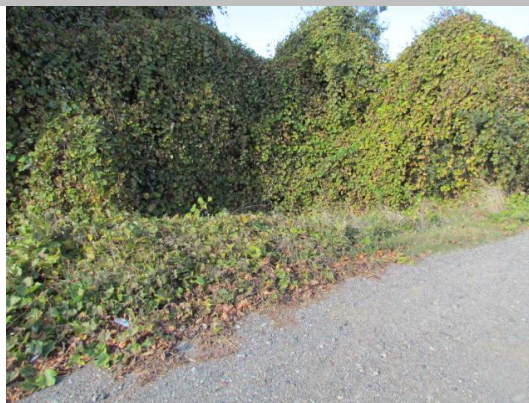
Photo 1 of 5 : SP_2015_RD0765_211_81_20150309_00064.jpg

Looking west at dense berryvines and wildroses on landside shoulder and slope. (November 2011)

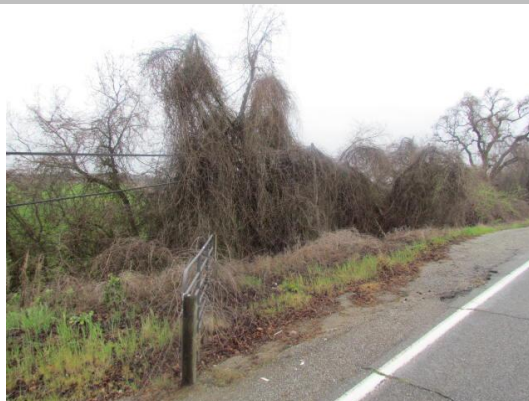
Photo 2 of 5 : SP_2015_RD0765_211_81_20150309_00065.jpg

Looking northwest at vines on landside toe spring 2012.

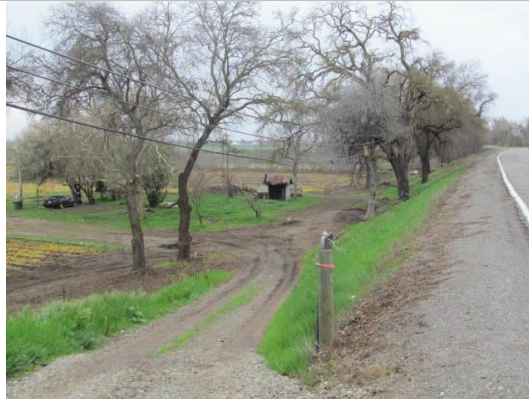
Photo 3 of 5 : SP_2015_RD0765_211_81_20150309_00066.jpg

Looking northwest at trimmed trees and vegetation on landside slope and toe.

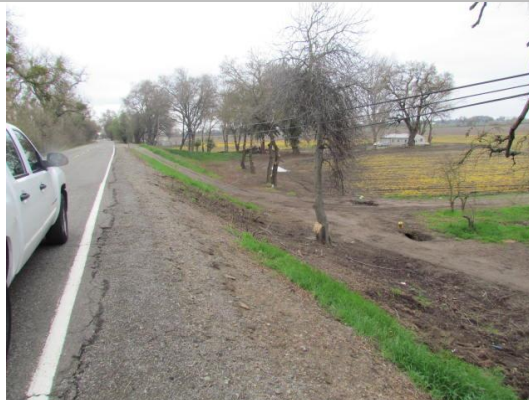
Photo 4 of 5 : SP_2015_RD0765_211_81_20150309_00067.jpg

Looking southwest at trimmed trees and vegetation on landside slope and toe.

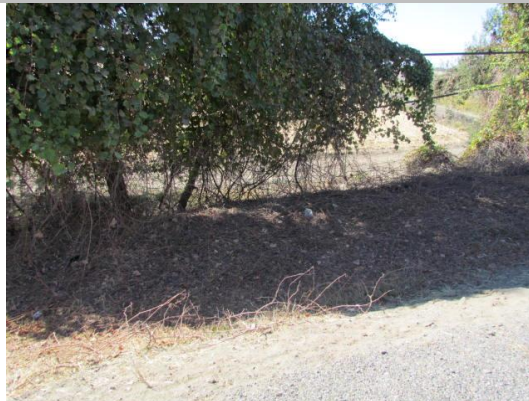
Photo 5 of 5 : SP_2015_RD0765_211_81_20150309_00068.jpg

Looking west at trimmed trees on landward slope.

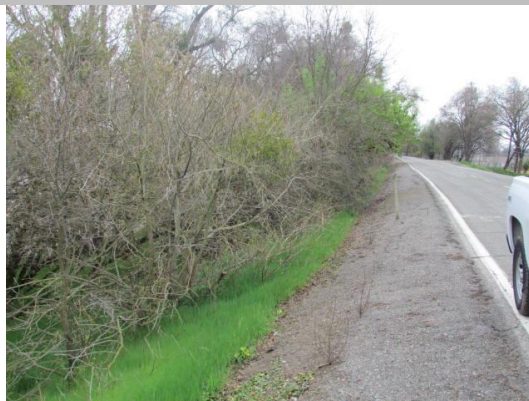
Photo 1 of 2 : SP_2015_RD0765_211_6_20150309_00007.jpg

Looking south (downstream) at untrimmed trees on waterward slope.

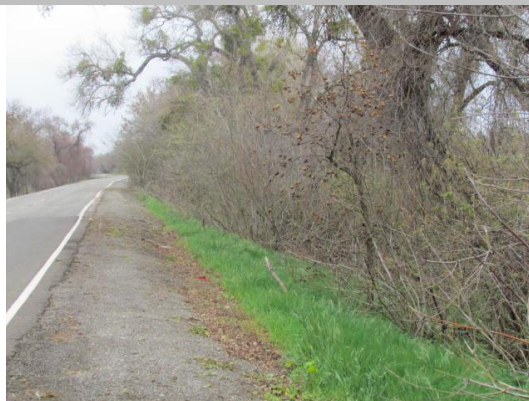
Photo 2 of 2 : SP_2015_RD0765_211_6_20150309_00008.jpg

Looking north (upstream) at untrimmed trees on waterward slope.

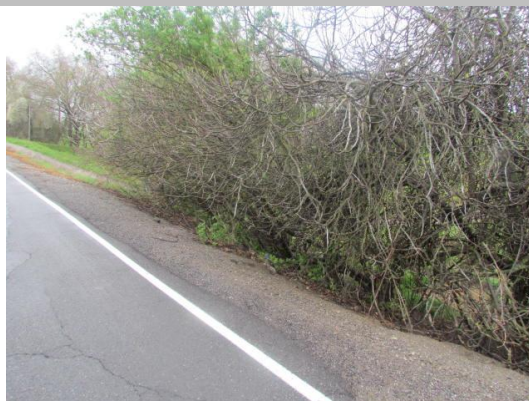
Photo 1 of 1 : SP_2015_RD0765_211_40_20150309_00046.jpg

Looking southwest at fig trees and other trees on landside slope and toe.

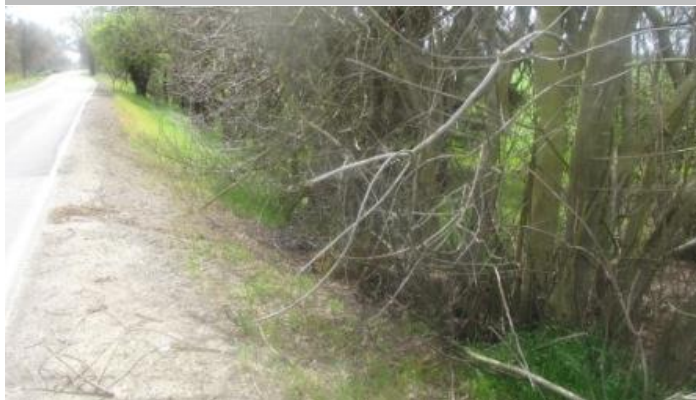
Photo 1 of 4 : SP_2015_RD0765_211_37_20150309_00042.jpg

Looking downstream (south) at trees on landside slope & toe from 2010 fall inspection.

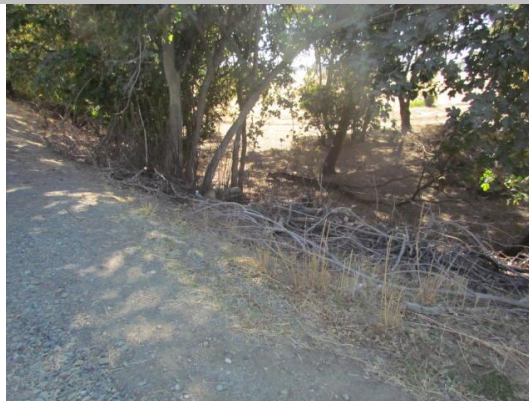
Photo 2 of 4 : SP_2015_RD0765_211_37_20150309_00043.jpg

Looking southwest at trees on landward slope.

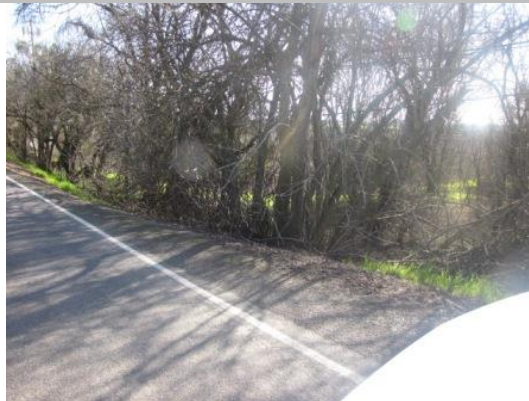
Photo 3 of 4 : SP_2015_RD0765_211_37_20150309_00044.jpg

Looking downstream (southwest) at dense trees on landside slope and toe.

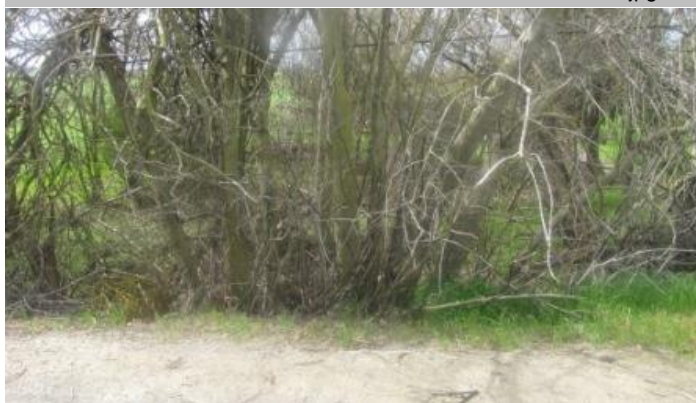
Photo 4 of 4 : SP_2015_RD0765_211_37_20150309_00045.jpg

Looking west at trees on landside slope & toe.

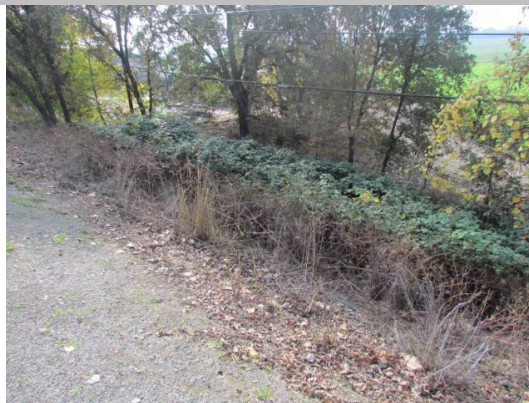
Photo 1 of 1 : SP_2015_RD0765_211_48_20150309_00049.jpg

Looking southwest at dense vegetation on landside slope and toe.

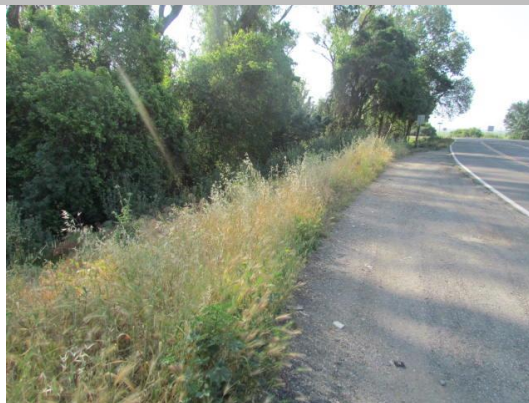
Photo 1 of 1 : SP_2015_RD0765_211_1_20150424_00071.jpg

Looking southeast at dense vegetation on waterward slope.

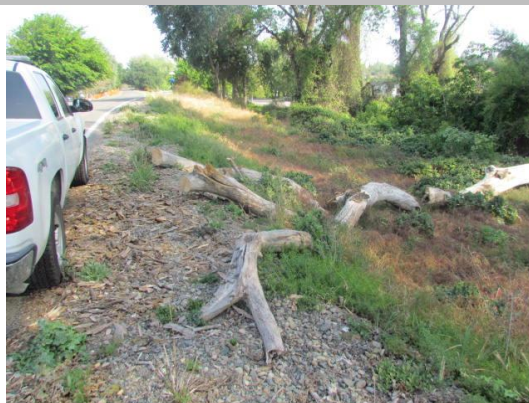
Photo 1 of 1 : SP_2015_RD0765_211_7_20150424_00072.jpg

Looking north at down tree across waterward slope.

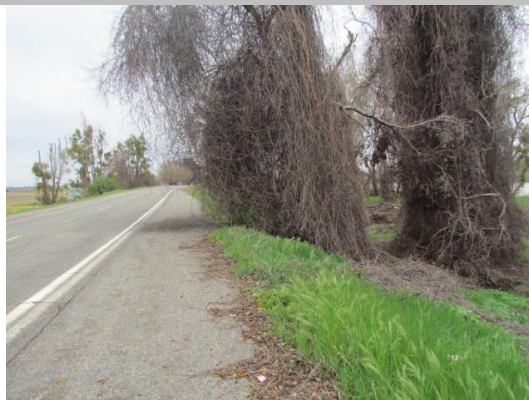
Photo 1 of 1 : SP_2015_RD0765_211_4_20150309_00004.jpg

Looking north at untrimmed trees on waterward slope.

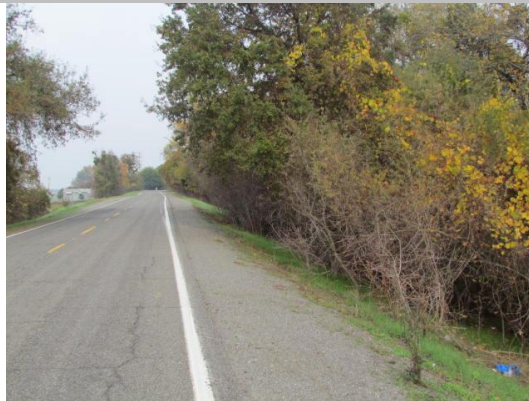
Photo 1 of 2 : SP_2015_RD0765_211_5_20150309_00005.jpg

Looking north at dense vegetation on waterside slope. (Fall Inspection 2012)

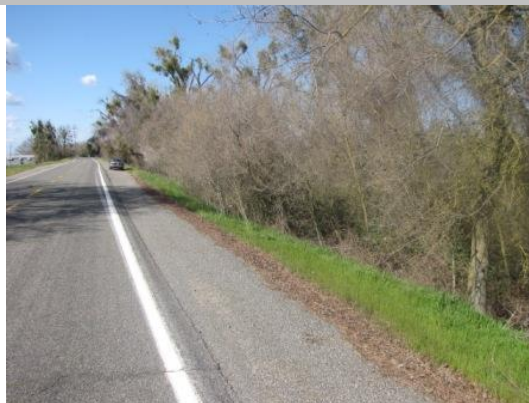
Photo 2 of 2 : SP_2015_RD0765_211_5_20150309_00006.jpg

Looking upstream (north) at dense trees on waterside slope.

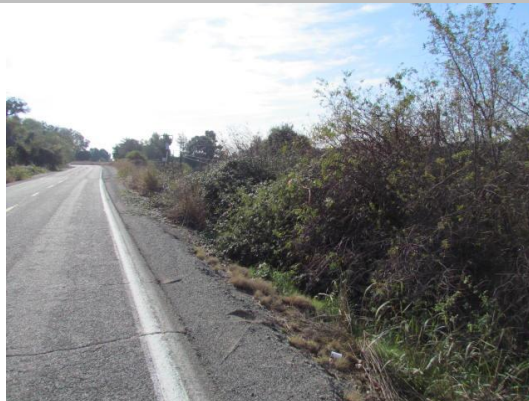
Photo 1 of 6 : SP_2015_RD0765_211_29_20150309_00030.jpg

Looking south at dense vegetation on landside shoulder and slope.
(November 2011)

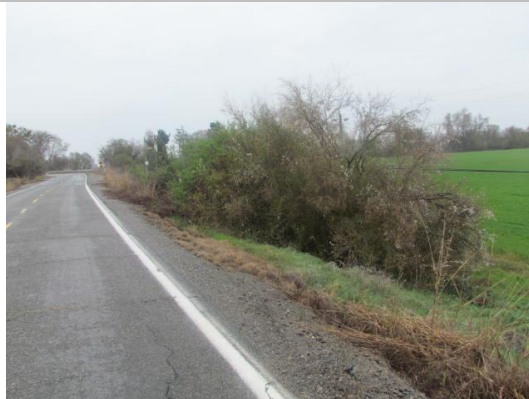
Photo 2 of 6 : SP_2015_RD0765_211_29_20150309_00031.jpg

Looking south at dense vegetation on landside slope and toe spring
2012.

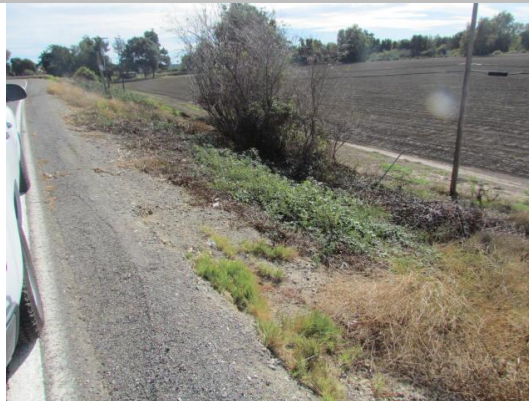
Photo 3 of 6 : SP_2015_RD0765_211_29_20150309_00032.jpg

Looking south at moderate vegetation on landward slope and toe. (Fall 2014)

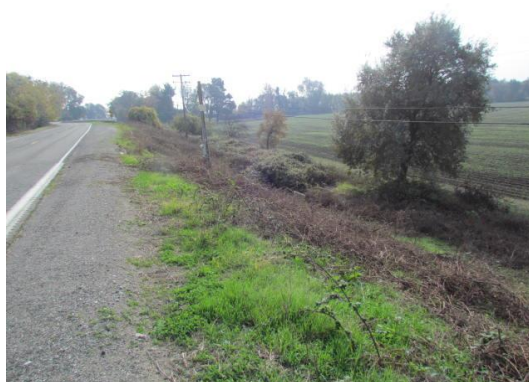
Photo 4 of 6 : SP_2015_RD0765_211_29_20150309_00033.jpg

Looking southwest at vegetation on landside slope and toe. (Fall Inspection 2012)

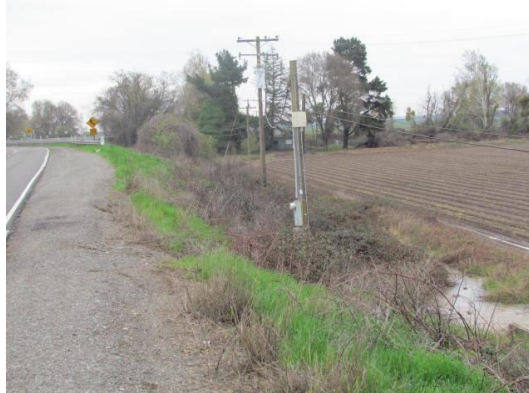
Photo 5 of 6 : SP_2015_RD0765_211_29_20150309_00034.jpg

Looking southwest at berryvines on landside slope.

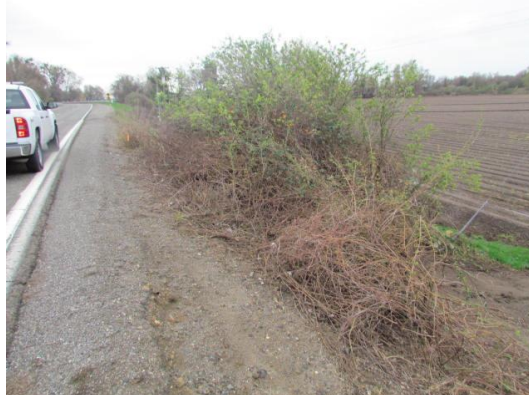
Photo 6 of 6 : SP_2015_RD0765_211_29_20150309_00035.jpg

Looking southwest at vegetation on landside slope.

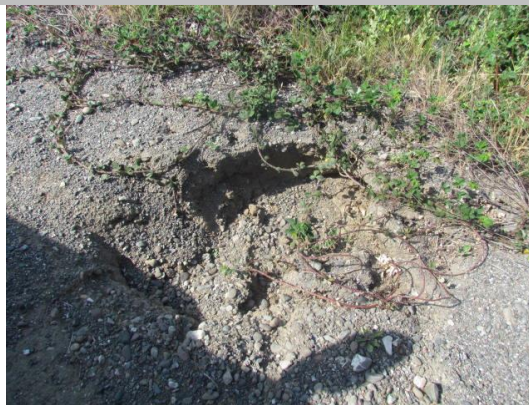
Photo 1 of 2 : SP_2015_RD0765_211_57_20150424_00073.jpg

Looking east at caving on landward shoulder.

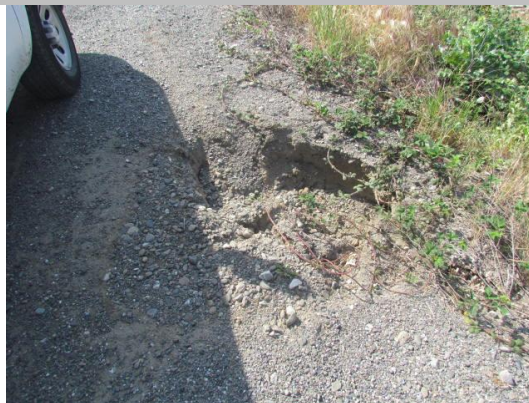
Photo 2 of 2 : SP_2015_RD0765_211_57_20150424_00074.jpg

Looking south at caving on landward shoulder.

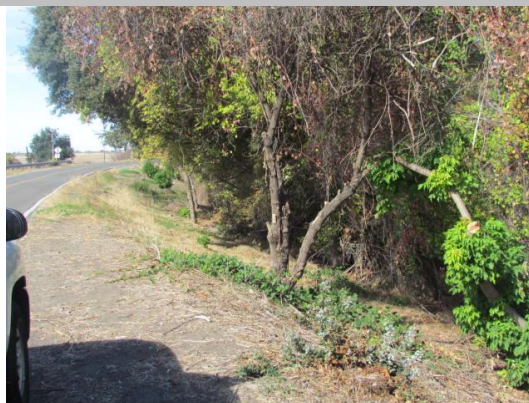
Photo 1 of 2 : SP_2015_RD0765_211_53_20150309_00055.jpg

Looking north at trimmed trees on waterward slope. (Fall 2014)

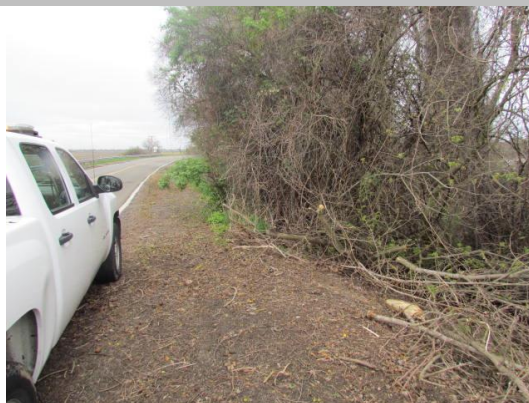
Photo 2 of 2 : SP_2015_RD0765_211_53_20150309_00056.jpg

Looking north at dense vegetation on waterward slope.

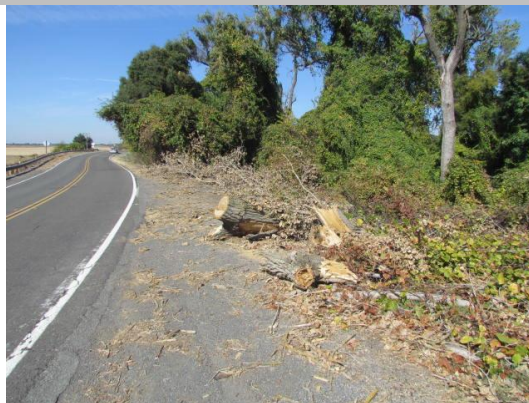
Photo 1 of 3 : SP_2015_RD0765_211_13_20150309_00016.jpg

Looking northeast at tree limbs on waterward slope.

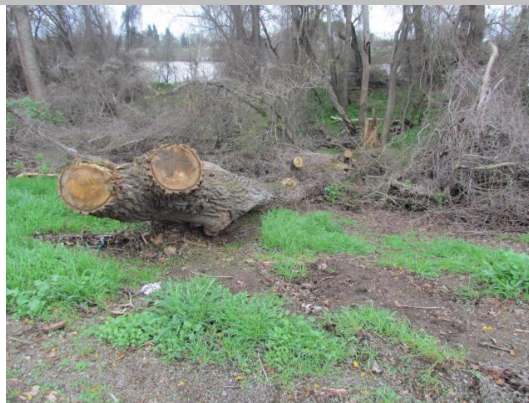
Photo 2 of 3 : SP_2015_RD0765_211_13_20150309_00017.jpg

Looking east at large tree limb on waterward slope.

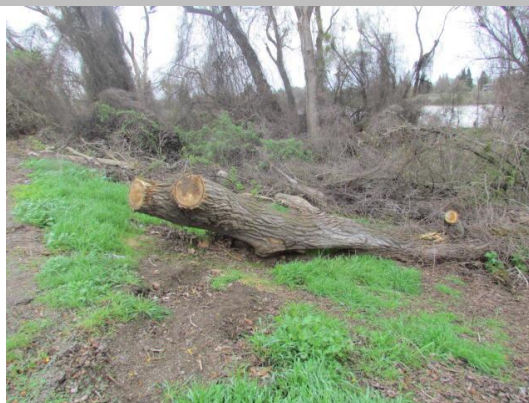
Photo 3 of 3 : SP_2015_RD0765_211_13_20150309_00018.jpg

Looking north at large tree limb on waterward slope.

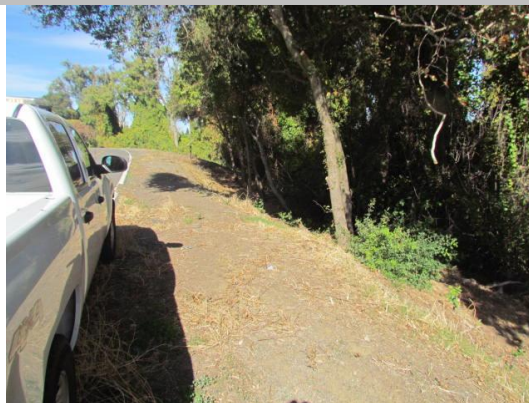
Photo 1 of 2 : SP_2015_RD0765_211_52_20150309_00053.jpg

Looking north (upstream) at trimmed trees on landward slope. (Fall 2014)

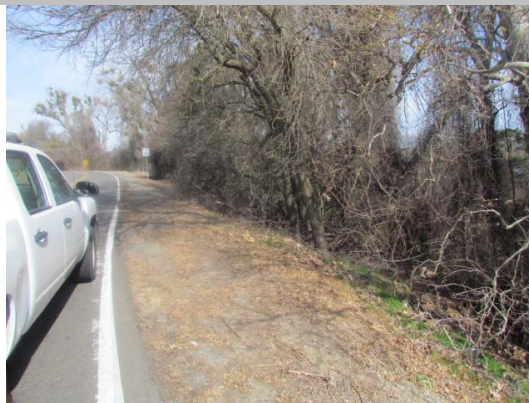
Photo 2 of 2 : SP_2015_RD0765_211_52_20150309_00054.jpg

Looking north (upstream) at dense trees on landside slope.
